Challicum Hills Wind Farm

Bushfire Mitigation Plan

Pacific Hydro

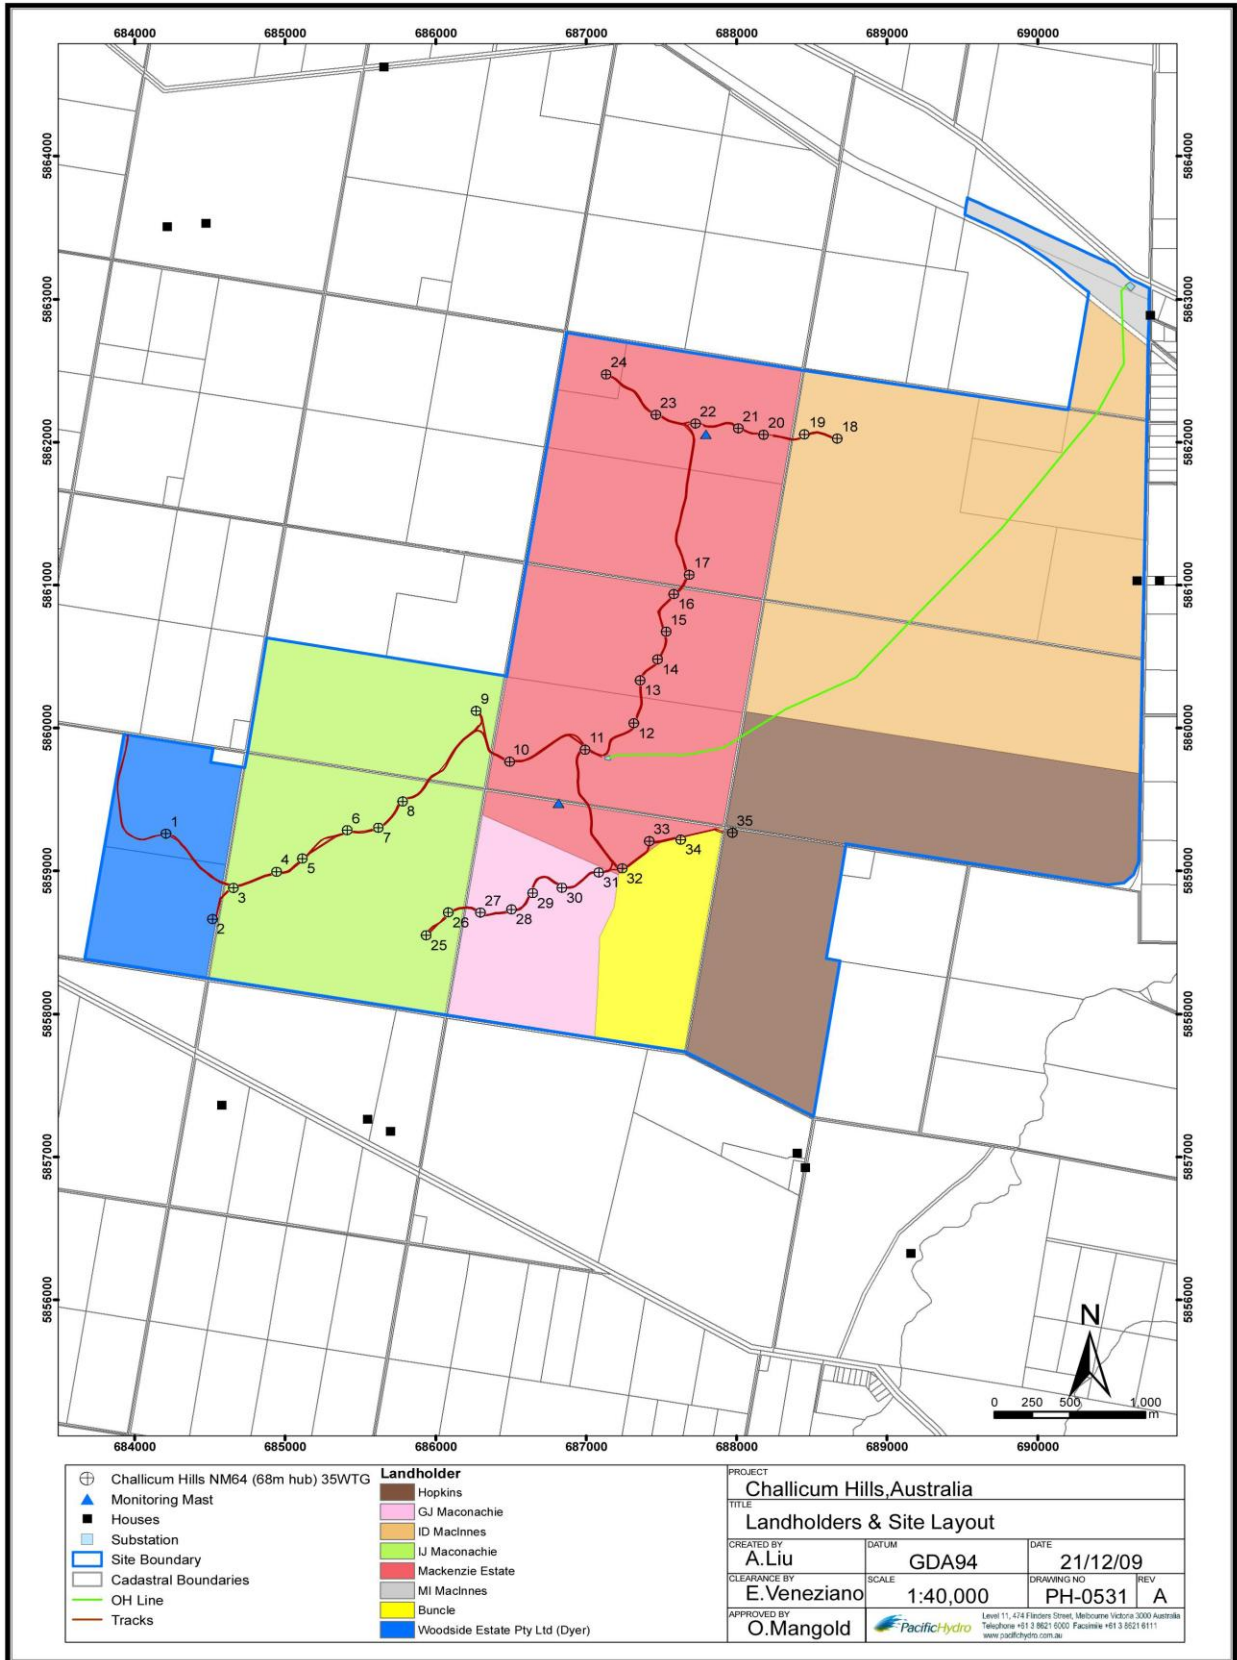
Appendix A: Challicum Hills Wind Farm Site Layout showing the location of Turbines, CHWF Substation, the Underground and Overhead electric lines and BGR Substation – Site Layout. In accordance with Regulation 5, Section (g).
